Renewing Michigan's Capitol 2014-2016

MICHIGAN STATE CAPITOL COMMISSION

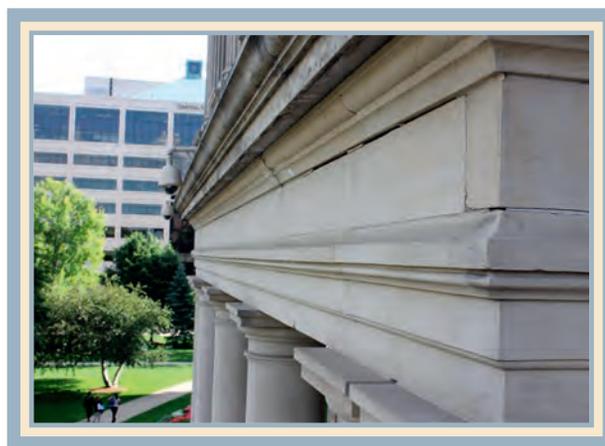
Stone and mortar are both subject to regular expansion and contraction cycles caused by severe temperature fluctuations. This can break the mortared joints and allow water to enter. When this happens and the water freezes, it can cause the stone to spall, or fracture. Therefore, the restoration of the stonework began by grinding out, cleaning, and repointing (or re-mortaring) failed or failing joints, a slow and highly labor-intensive but necessary first step.

A series of open joints in the stonework on the Capitol’s east portico.

Once the joints were repaired, the stone itself was cleaned to reduce dirt and pollutants which had penetrated into its pores. In addition, an aluminum sheet metal covering, or flashing, was installed to protect weathered and worn surfaces at the top of some cornices near the roofline. This flashing was designed to be invisible from the sidewalk.

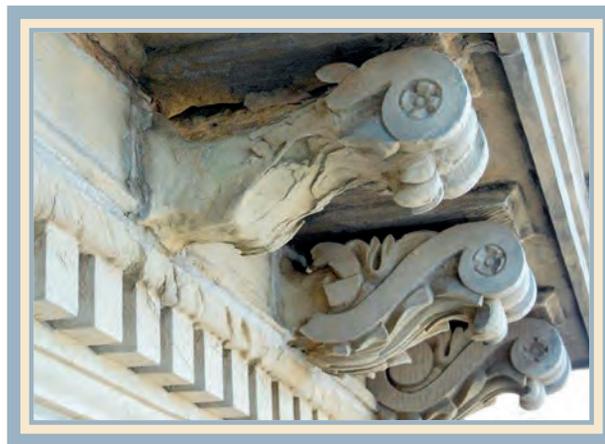
Early investigations revealed that many of the Capitol’s original sandstone modillions (ornamental brackets) under the roofline were badly damaged and disintegrating. The Michigan State Capitol Commission made the decision to remove the most severely damaged and replace them with newly carved modillions crafted from the same sandstone

This trio of modillions shows the incredibly varied condition of these original sandstone elements when the exterior renewal began.

as the originals. Modillions were replaced based on the degree of weathering, stone loss, and extreme discoloration. While the initial plan called for replacing 147 modillions, over 200 were eventually addressed.

The original modillions were carved in long blocks of stone that extended back into the Capitol's walls, underneath the roofline cornice. The decision was made to cut deteriorated modillions off flush with the surrounding stonework, leaving the recessed portion of the modillion in place. The new modillions were carved by hand, just like the originals. Two different carvers were involved, since there were too many for one person to craft alone. The modillions arrived by the dozen on large pallets that were stored on the Capitol's west lawn. Each was mounted by inserting one end of a steel rod into the modillion and the other end into the intact stonework.

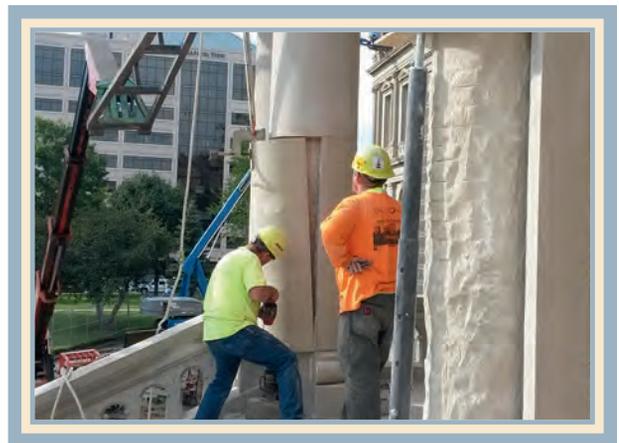
The four central columns on the east (front) portico and the two central columns on the south portico were repaired during the summer of 2015. These large freestanding stone columns were in fair to poor condition due to graffiti, weathering, the improper use of salts and snow melting agents, and poor patching jobs.

Masons watch as a large stone dutchman repair is carefully lowered into place between a column and the adjoining stone balustrade on the Capitol's east stairs.

To address this damage, a technique called a "dutchman repair" was undertaken. This involves removing damaged stone and cutting new stone to exactly fit the damaged area. Beginning at the east portico, where the four central columns had all suffered damage, sections of stone — approximately two inches deep and over six and a half feet tall, including portions of the lower column and base — were removed using specially designed power tools.

Dutchmen replacements were carefully carved offsite and installed under the guidance of master stonemasons. Installing and mortaring the new, massive dutchmen proved to be an impressive feat, requiring a crane and steady hands. The process was repeated at the south portico. The dutchmen made for these columns measure approximately four and a half feet tall, and only include stone on the column's lower shaft. From a distance the repairs are completely invisible.

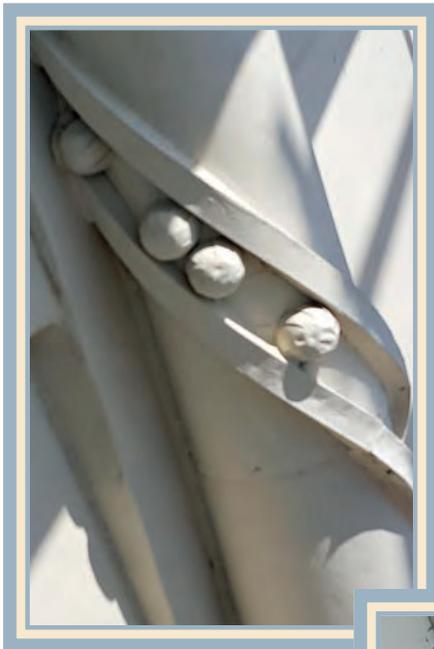
Hundreds of decorative balls were missing from the garland that appears to wrap around the dome’s sixteen ribs. Every single one was replaced as a part of the renewal project.

Workers initially thought that most of their time would be spent sealing open joints in the metalwork and replacing worn fasteners. Yet as they set about these projects, they began to notice that a significant number of the dome's original decorative elements were missing. Among the missing pieces were acanthus leaves on the dome's Corinthian columns, scrollwork found around the dome's octagonal windows, and decorative balls (or pellets) and their accompanying molding that appear to spiral around the dome's ribs. Also missing were a significant number of similar balls designed to ornament the ribs on the dome's lantern.

As soon as the Capitol Commission became aware of this, they resolutely agreed that the dome project would not be complete until ALL missing elements were replaced. Thus began an intense phase of study to determine exactly what and how many pieces were missing, and how and where to find replicas.

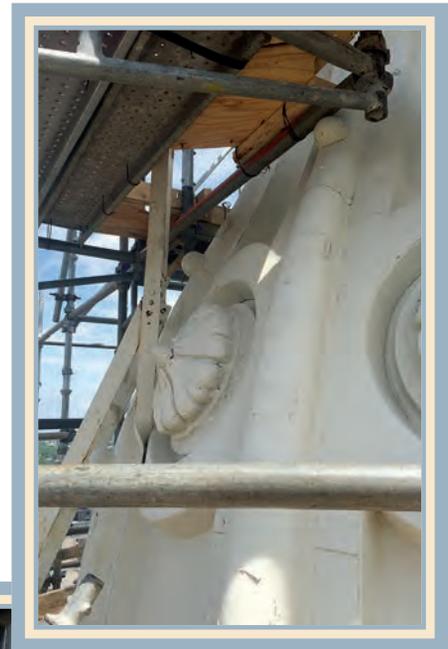
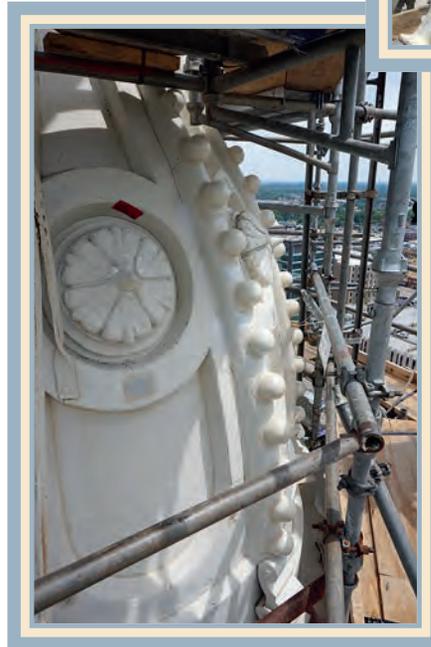
The remnants of old caulk, as seen in the image above, identified where decorative balls and other elements were missing. Replacements were eventually attached to the dome at these very same locations.

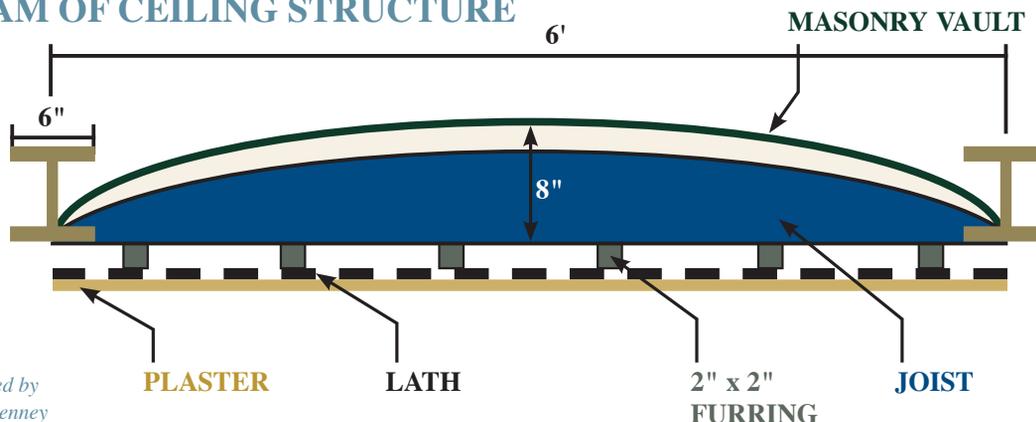
DIAGRAM OF CEILING STRUCTURE

The next intervention began in the fall of 2015, following the discovery that the ceilings were beginning to sag dangerously in some areas. Alarmed at this sudden development, the Michigan State Capitol Commission quickly reached out to experts who could reattach the original ceilings.

Once the locations of the nails were determined, Canning’s crew drilled a series of 3/4" access holes near them. Aware that the smooth nails used during construction had proven to be an inadequate long-term choice, they began reattaching the furring to the joists using 4"-6" GRK RSS Round-Head Wood Screws, selected for their deep, coarse threading and their resistance to corrosion.

Once the screws were installed and the lath, furring, and joists were reattached, expert plasterers carefully repaired the holes using a three coat plaster system consistent with the Capitol’s original ceilings. When the plaster finished curing, decorative artists painted each white plaster patch to match the elaborate artwork. Today, as a result of their careful work, this treatment is nearly invisible to the human eye.

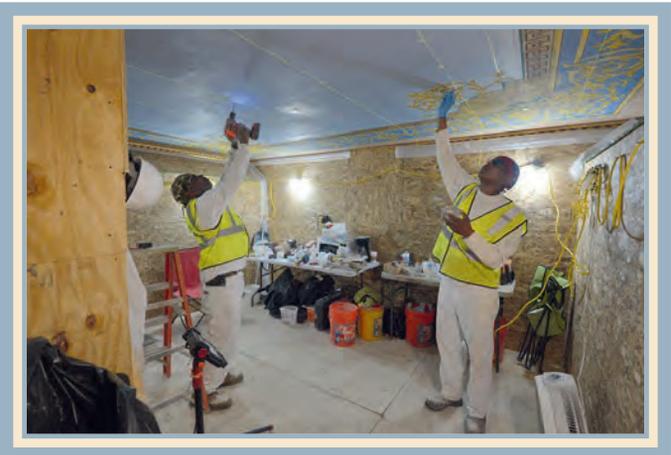
Employees from the John Canning Company at work on a blue ceiling panel. The worker on the left drills into the historic plasterwork while the worker on the right plasters a hole closed.

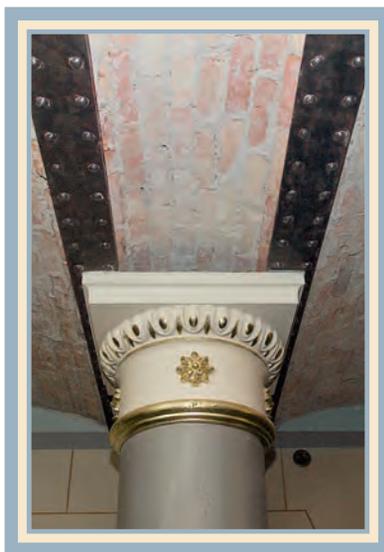
The study showed that the original plaster contained both a lime-based brown coat and a lime topcoat, in keeping with typical 19th century lime plasters. The analysis also noted that it was unlikely that the nature of the original lime plaster itself caused the delamination and cracking.

The study suggested that more recent modifications to the plaster were likely to blame. These most likely occurred at least twice: once when conduit for wires was tucked into the plaster, and once during the Capitol’s restoration (1987-1992), when two skim coats of gypsum plaster were added to the ceiling. These interventions caused movement of both the brick vaults and the plaster, allowing moisture to seep in. And, although a traditional, breathable lime plaster can absorb and release moisture, gypsum plaster does not have this capability. The introduction of the gypsum layers was, most likely, what caused the plaster to crack and the paint to peel.

The ground floor ceilings are comprised of brick vaults supported by iron beams and columns. The vaults and beams were stripped bare at the beginning of the project. The supporting column was repainted once the ceiling was completed.

The team began by applying a scratch coat of plaster, so-called because the plaster is heavily scratched, or textured, so the next layer of plaster will adhere to it. The plaster contained synthetic goat hair, used as a binding agent in much the same fashion as the horsehair in the original plaster. The scratch coat required at least a week to cure, based on the temperature and the humidity levels within the building.

Once the brown coat had cured, a finish coat of plaster was applied. This layer was topped using a product called “Keim,” a silicate mineral paint named after Adolf Wilhelm Keim, who patented it in 1878. Keim paint allows lime plaster to breathe, preventing damage to the paint and plaster. It is also highly durable.
