Renewing Michigan's Capitol 2014-2016

MICHIGAN STATE CAPITOL COMMISSION

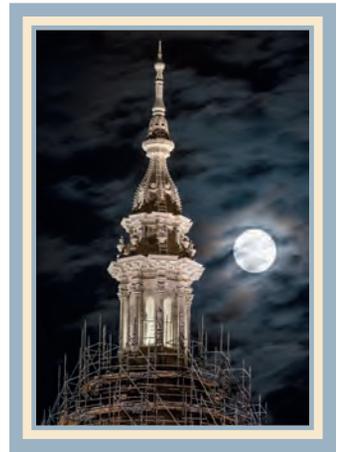
A dramatic photo of the lantern on the Capitol’s dome as it emerges, freshly painted, from the scaffolding.

The Capitol’s dome is made of cast, wrought, and rolled sheet iron produced by the S.J. Creswell Ironworks Company of Philadelphia, Pennsylvania. Heralded by architects for its strength, the ease with which it could be cast into ornamental shapes and forms, and its resistance to fire, iron was a very popular building material in America from the 1830s until the early 20th century. Yet iron also requires consistent maintenance, as it expands and contracts due to temperature fluctuations. Iron must be kept sealed and painted to prevent rusting and deterioration from rain and snow. Although in the past the dome had been repainted about every fifteen years, almost twenty-five years had passed since its last paint job. The dome was showing signs of neglect.

In 2015 the Michigan State Capitol Commission launched a major exterior restoration to address issues relating to the Capitol’s exterior. Chief among the projects was repainting and resealing the Capitol’s graceful and elegant dome.

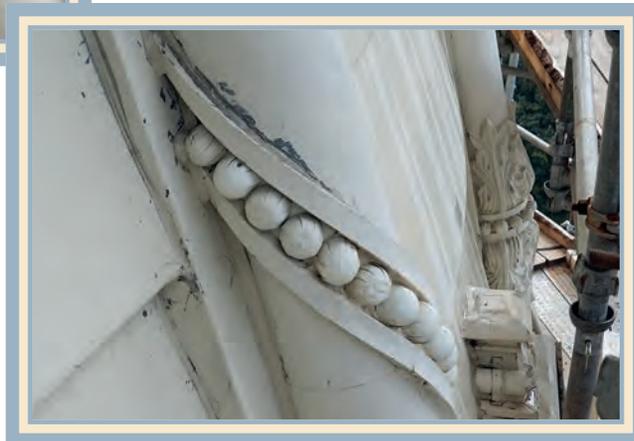
Before the project could begin, a special scaffold had to be built around the dome. Brand Energy and Infrastructure Services undertook this complicated task, which began on April 6, 2015. The project lasted nearly seven long weeks, ending on May 22, 2015.

Workers initially thought that most of their time would be spent sealing open joints in the metalwork and replacing worn fasteners. Yet as they set about these projects, they began to notice that a significant number of the dome's original decorative elements were missing. Among the missing pieces were acanthus leaves on the dome's Corinthian columns, scrollwork found around the dome's octagonal windows, and decorative balls (or pellets) and their accompanying molding that appear to spiral around the dome's ribs. Also missing were a significant number of similar balls designed to ornament the ribs on the dome's lantern.

As soon as the Capitol Commission became aware of this, they resolutely agreed that the dome project would not be complete until ALL missing elements were replaced. Thus began an intense phase of study to determine exactly what and how many pieces were missing, and how and where to find replicas.

Ultimately hundreds, if not thousands, of decorative pieces were replaced, restoring the dome — for the very first time — to its original majesty.

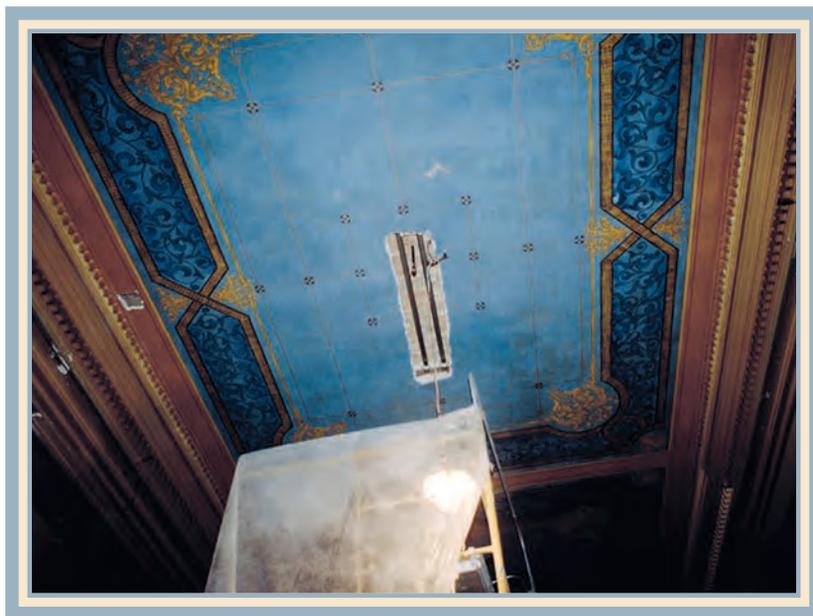
At the same time the ceiling project was taking place, the decision was made to remove the large “Michigan chandeliers” that hang in the corridors. Originally designed to burn gas, the chandeliers were electrified sometime in the late 19th or very early 20th century. Shocked restoration workers discovered that these massive chandeliers, weighing in at a hefty 400 pounds each, were supported only by their original gas pipes. Upon learning this, each chandelier was taken down, and a small section of the plaster directly around the chandelier was removed so that appropriate plates and bolting could be installed. The plaster was then carefully patched and painted.

Workers were forced to cut into the corridor ceilings to install stronger supports for the Capitol’s massive Michigan chandeliers during the restoration.

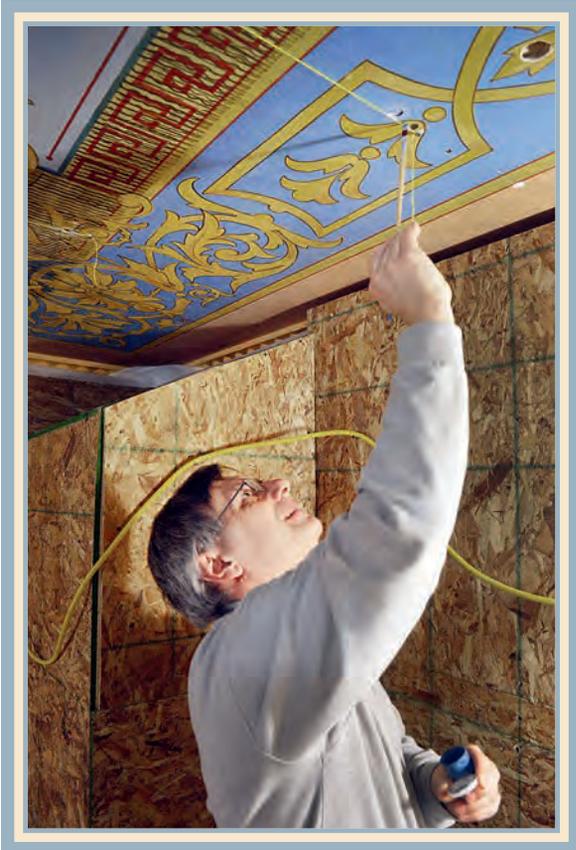
The next intervention began in the fall of 2015, following the discovery that the ceilings were beginning to sag dangerously in some areas. Alarmed at this sudden development, the Michigan State Capitol Commission quickly reached out to experts who could reattach the original ceilings.

A decorative painter from the John Canning Company brushes blue paint over a small patch in the ceiling.

Once the locations of the nails were determined, Canning’s crew drilled a series of 3/4" access holes near them. Aware that the smooth nails used during construction had proven to be an inadequate long-term choice, they began reattaching the furring to the joists using 4"-6" GRK RSS Round-Head Wood Screws, selected for their deep, coarse threading and their resistance to corrosion.

Once the screws were installed and the lath, furring, and joists were reattached, expert plasterers carefully repaired the holes using a three coat plaster system consistent with the Capitol’s original ceilings. When the plaster finished curing, decorative artists painted each white plaster patch to match the elaborate artwork. Today, as a result of their careful work, this treatment is nearly invisible to the human eye.

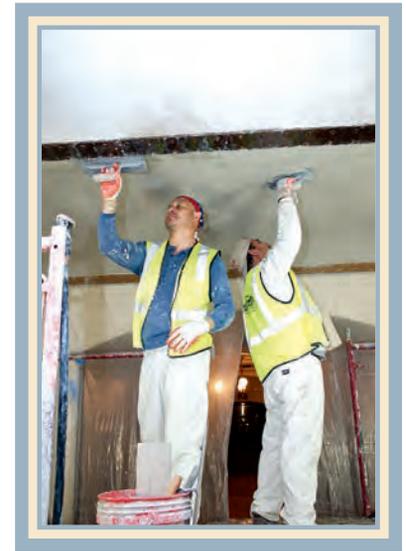
During the restoration of the Capitol (1987-1992), the original plaster ceilings on the ground floor were skim-coated with a layer of gypsum plaster and repainted. Unfortunately, these materials proved to be incompatible with the original lime plaster, resulting in cracking and flaking. Repeated attempts to address the problem failed. Ultimately the Commission decided to replaster the ground floor corridors. The project was carried out during the spring and summer of 2016.

Plasters from the John Canning Company smooth a coat of plaster in the vault immediately south of the rotunda.

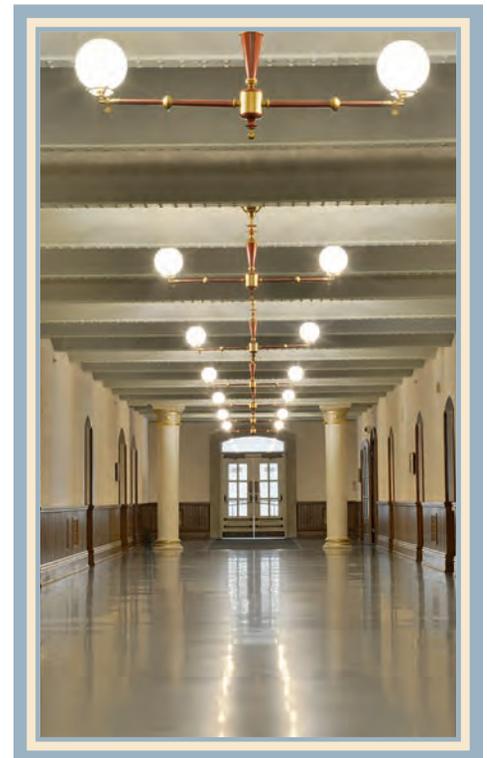
The new completed plaster vaults in the south corridor.

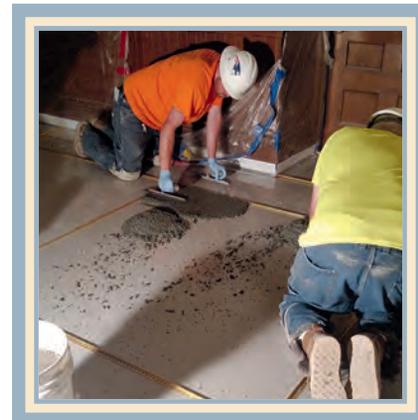
As the years passed the gray ceramic tile proved to be a poor choice, as the floor cracked and chipped under heavy use. The Capitol Commission, concerned with safety, voted to replace the tile floor with a new terrazzo surface. Projected to last 100 years, this new terrazzo is durable, easy to maintain, and handsome. Great effort was made, however, to ensure that the terrazzo pays homage to Myers’s original specification for a slate floor. The predominantly dark gray terrazzo was poured into a coursed ashlar block pattern, reminiscent of how slate tiles were traditionally laid. Sections of the terrazzo contain gray, blue, green, and copper colored chips suggesting the colors commonly seen in late 19th century slate flooring.

The installation of the terrazzo floor began in the west wing. Here two members of the team at Artisan Tile Inc. of Brighton, Michigan, trowel freshly mixed terrazzo.

At first, the initial finish was rough, with many chips breaking the surface of the epoxy. The terrazzo was left in this condition to dry, or cure, for a period of time. Once the entire hallway had completely cured, workman brought in large machines to grind the surface of the terrazzo to create a smooth finish. Finally, the surface was polished.

The project was divided into four segments, allowing traffic to continue to flow through the ground floor all summer. Work began in the west wing, followed by the east, north, and south wings. The project was completed and the entire ground floor open and accessible just before Labor Day.

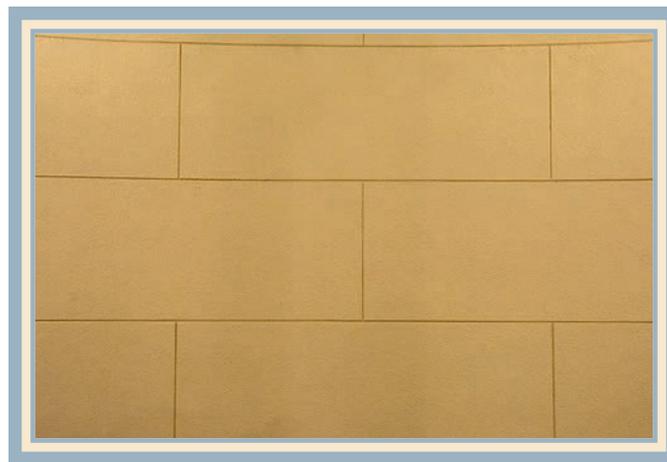
The faux “stone” walls in the rotunda still contain original plasterwork from the late 19th century. The plaster was repainted as a part of the Capitol’s renewal.

The Capitol Commission, concerned with damage that had been done to the walls since the restoration, voted to repaint the walls and the false mortar joints. Appropriate paint colors were chosen based on the color of the exterior sandstone and its mortar. The work was executed by the John Canning Company.

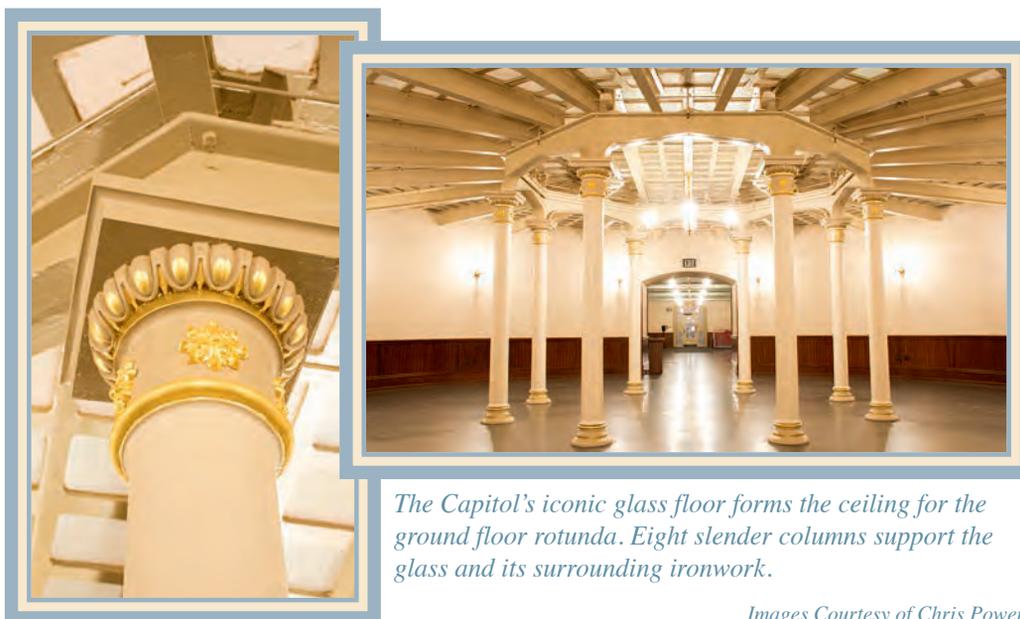
The Capitol Commission, concerned with the damage and wear evidenced on both the columns and the rotunda ceiling, voted to repaint these surfaces. After much discussion, the decision was made to use the buff and taupe colors found on the faux sandstone walls of the ground floor, as the original color of the ceiling and columns is not known.

The Capitol’s iconic glass floor forms the ceiling for the ground floor rotunda. Eight slender columns support the glass and its surrounding ironwork.

H & H Painting Company prepared and painted the rotunda ceiling over the course of several nights. Joshua Risner, the Capitol’s decorative painter, painted the columns. Now, once again, the rotunda ceiling and ground floor columns have an appropriate, dignified appearance.
